DATE: February 21, 2021 INVESTIGATOR: D. Bubb

STOP 1 – HIGHWAY 66 WEST of ASHLAND GUN CLUB

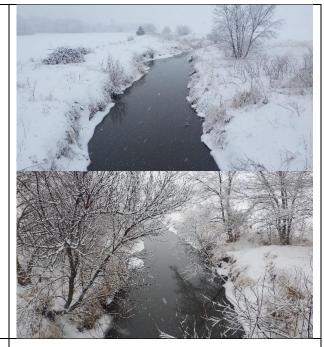
Open stream.

Current heavy snow and fog. No noticeable discolored water or odor.

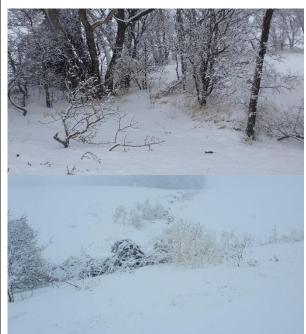
STOP 2 – North of the Intersection of COUNTY ROADS 6 & F

Stream covered in snow/ice.

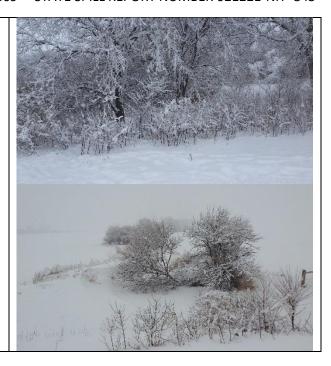
STOP 3 - Road 7/Highway 66

Did not want to pull too far off the road as slick conditions would have allowed vehicle to slide down the side slope. Also, due to very heavy fog, did not want to leave vehicle on the road while out taking pictures as possible oncoming cars may have been coming and visibility was less than 1/8 to ½ mile. Pictures taken very rapidly while getting out of the vehicle momentarily.

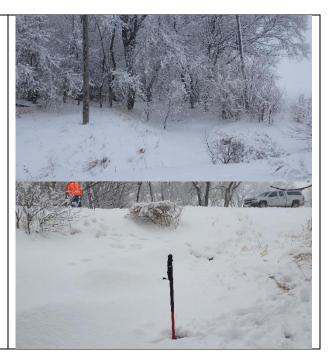
STOP 4 - County Road 8, North of Road H

There had been a hole in the ice from a previous investigation done by G. Michl. Chopped the new ice out of the hole with a chipper. Ice was likely 15 inches thick. Water was no more than an inch or two in the bottom of the hole. Some livestock smell in the hole and on the ice chisel.

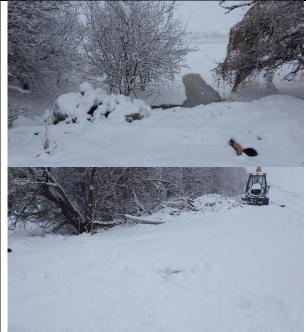
STOP 5 – UN-L Eastern Extension – North of County Roads 9 & J

Water is open to slush covered upstream. Water appeared to be dark.

Tractor/PTO set up to pump water from the stream.

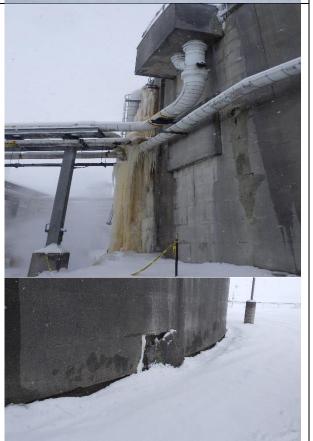
STOP 6 – ALTEN LLC FACILITY DIGESTERS

Water trickling from a digester causing a large ice cycle.

Damage to insulation on one of the digesters.
